STRUCTURE CONDITION REPORT

BARGE CANAL FAIRPORT-LOCKPORT

MATERIALS BUREAU

STRUCTURE CONDITION REPORT
BARGE CANAL - WESTERN SECTION
FAIRPORT TO LOCKPORT

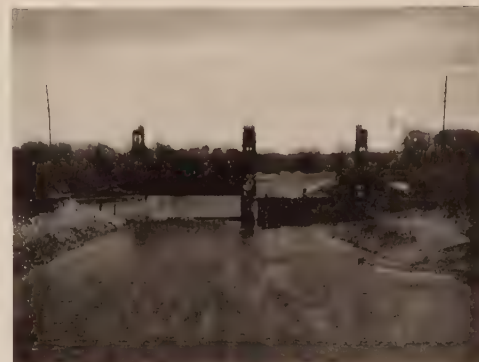
Looking West
Spencerport Guard Gate

Deterioration was noted along the top of all concrete walls and the center pier. Numerous cracks, scaling and delaminations indicate that the top 2 - 3 feet have been seriously affected.

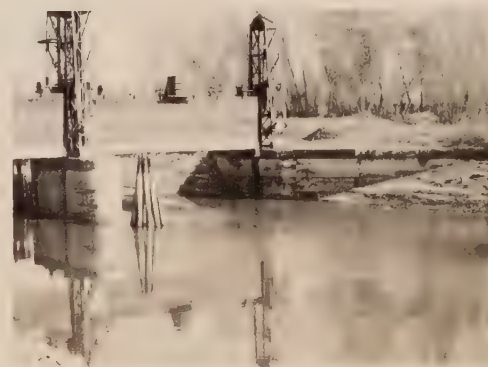
South Abutment and West End Center Pier
Spencerport Guard Gate

The south abutment was extensively delaminated and severely scaled. Cores #1 and 2, taken near the bottom of the abutment, showed that deterioration extended over $2\frac{1}{2}$ feet into the wall. The lower section of Core #2 contained 1 or 2 small fractures and had a compressive strength of 2485 p.s.i.

Required repairs include replacement of the top 2 - 3 feet of concrete on the walls and pier, and complete replacement or very extensive repair to the south abutment. Also, over 2 foot deep repairs are needed on the north abutment and on the sides of the center pier. Because of extensive deterioration in the south abutment, repairs to this structure are recommended now.

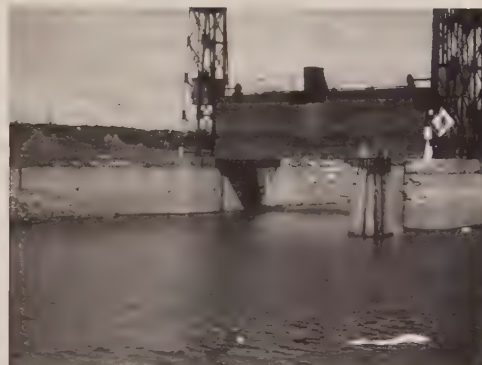
North Abutment and West End Center Pier
Spencerport Guard Gate

The concrete in the south abutment contained fractures which extend halfway or more into most of the walls. Center pier and north abutment concrete deterioration appears to be less, but also extensive.

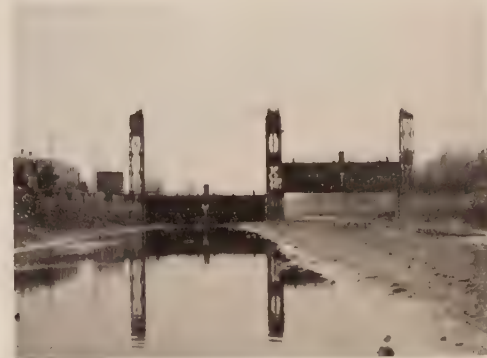
Looking West
Brockport Guard Gate

The Brockport Guard Gate is located 1 mile west of downtown Brockport. On March 31, 1976, this structure was visually inspected and sounded for delaminations. Due to the lack of any large areas of visual deterioration, no cores were taken from this structure.

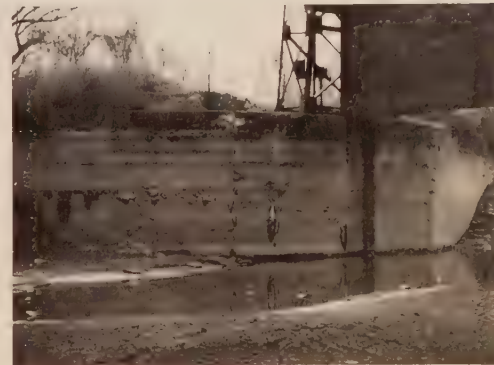
North Abutment
Brockport Guard Gate

Except for the top portions of all walls, the majority of delaminated concrete was found in the splaywalls on both sides of the abutments. Some scaling has occurred on these walls below the waterline, but all wall faces appeared in generally good condition. The abutments sounded in especially good condition with very little delaminated concrete.

Future repairs to this structure should include replacement of the concrete in the top 2-3 feet of the walls and pier. Also, all sections of the walls and pier faces which contain delaminated concrete should be repaired by removing the concrete to an approximate depth of 8-12 inches and bonding on a new concrete surface.

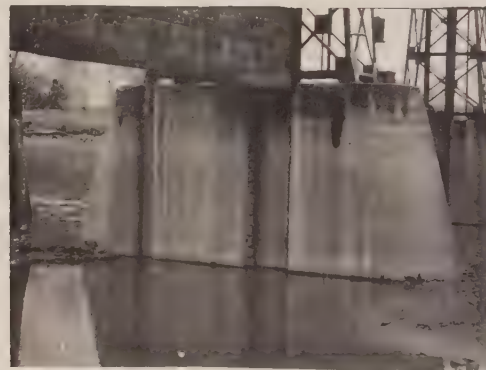
North Side Center Pier
Brockport Guard Gate

The center pier also contained little delaminated concrete, except for the pier noses. Both noses contained a much higher percentage of delaminated concrete than the sides, but all faces still appeared in good condition.

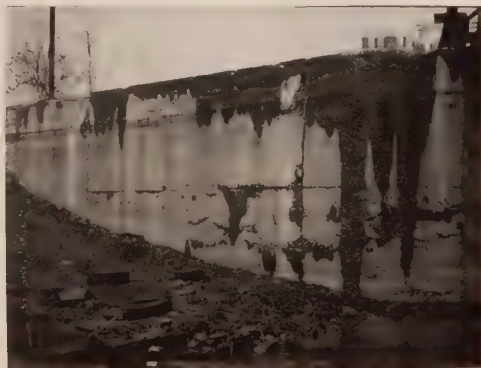
East Half South Abutment
Brockport Guard Gate

The most prevalent concrete deterioration on the structure has occurred to the top 2-3 feet above the waterline. Freeze-thaw action in this area has caused numerous cracks, scaling and delaminations. However, the concrete is still generally intact and will probably remain so for many years.

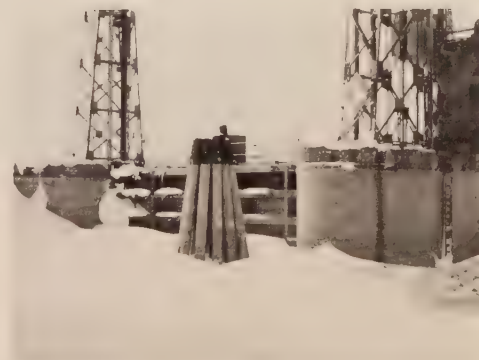
East Half South Abutment and Center Pier
Holley Guard Gate

As was observed in the majority of guard gates, the upper 2-3 feet of concrete in the center pier and walls contained numerous delaminations, cracks and scaled areas caused by freeze-thaw action.

The splaywalls at both ends of the south abutment were in much better condition than the other portions of the abutment. Gravel aggregate was used in the concrete for the splaywalls while crushed Medina sandstone was used as the concrete aggregate in the other portions of the structure.

Recommended repairs include replacement of the concrete in the top 2-3 feet of all walls and pier, and complete replacement or very extensive repair of the north abutment under the bridge. Also, 1-2 foot deep repairs are required in the other areas of delaminated or scaled concrete.

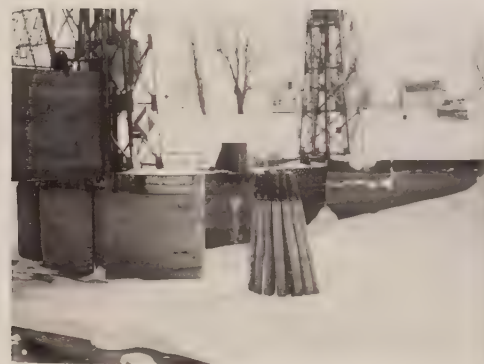
West Half South Abutment and Center Pier
Holley Guard Gate

The west nose of the center pier was disintegrating and a 5 foot high steel plate has been wrapped around the upper end to hold it together. Other areas of the pier were in much better condition. Core #2, taken from a solid sounding area on the north side of the pier, contained deterioration only $6\frac{1}{2}$ inches deep. The lower portion of this core had a compressive strength of 4875 p.s.i. even though it contained 1 or 2 small fractures.

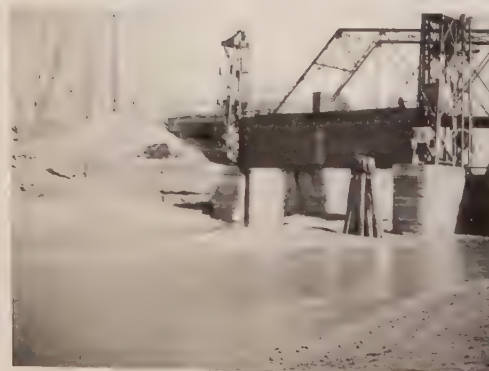
West Half North Abutment and Center Pier
Holley Guard Gate

The majority of the walls on the entire structure contained extensive delaminations. The north abutment, under the bridge, exhibited areas of scaling 1 foot deep caused by joint leakage. Deep scaling also existed on other areas of the structure. Core #1, taken from under the bridge, contained deterioration 17 inches deep with deeper deterioration existing in adjacent scaled areas.

The walls of the north abutment under the bridge contain fractures which extend halfway or more through the walls. Other areas of the abutments and pier also contain deep deterioration. Because of this extensive deterioration, repairs are recommended for the near future.

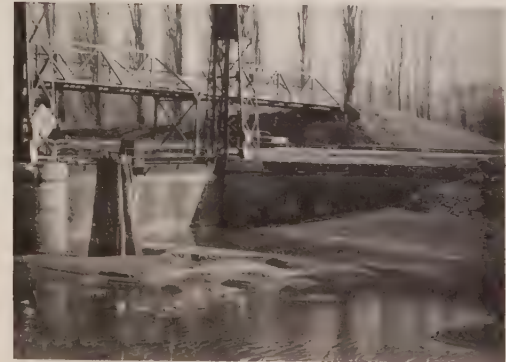
West Half South Abutment and Center Pier
Albion Guard Gate

The south abutment contained very extensive areas of delaminated concrete, many cracks, and a few deep scale areas. Repairs to the top 4 feet of the center of this abutment have recently been made.

Freeze-thaw action has caused numerous cracks, scaling and delaminations along the top 2-3 feet of the structure. The south abutment and center pier appeared to contain the most deterioration.

These repairs should include replacement of the concrete in the top 2-3 feet of the walls and pier. Also, all sections which contain delaminated concrete should be repaired by removing the existing concrete to an approximate depth of 8-12 inches and bonding on a new concrete surface.

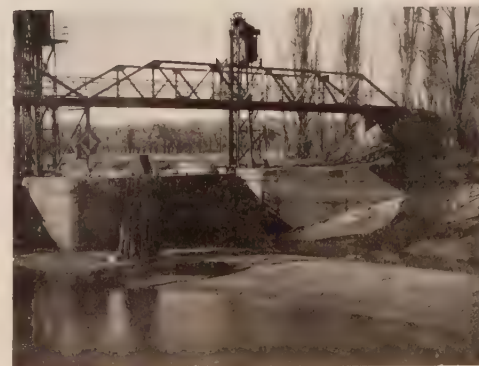
East Half North Abutment and Center Pier
Albion Guard Gate

On the north abutment the majority of delaminated concrete was found in the splaywalls. Very little delaminated concrete was detected near the center of this abutment. Also, some sections of the top 2-3 feet of the abutment were completely delaminated.

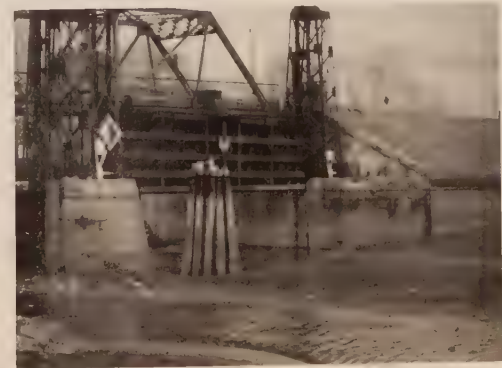
West Half Center Pier and South Abutment
Medina Guard Gate

The most prevalent concrete deterioration on the structure has occurred to the top 2-3 feet above the water line. Freeze-thaw action in this area has caused numerous cracks, scaling and delaminations. However, the concrete was still generally intact and will probably remain so for many years.

The north side of the center pier appeared in good condition. Both noses and the southwest side contained areas of delaminated concrete and some small areas have started to scale.

The concrete in the structure is still in relatively good condition and no repairs are necessary at this time. Future repairs will require that the top 2-3 feet of the walls and pier be replaced. All delaminated concrete in the wall and pier faces will require removal to an approximate depth of 8-12 inches with new concrete bonded on to form a new surface.

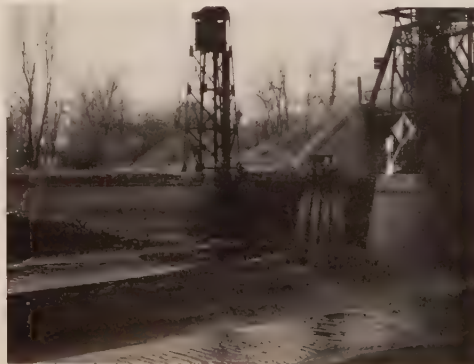
West Half Center Pier and North Abutment
Medina Guard Gate

Very little delaminated concrete was detected on either abutment. All wall faces appeared in good condition with only very small areas of scale or other deterioration noted.

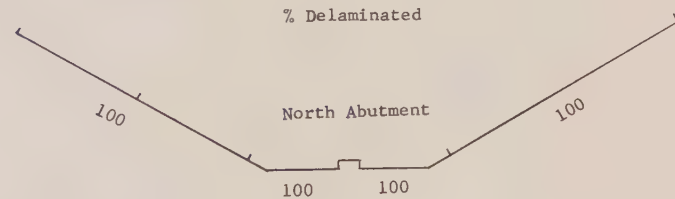
All walls sound deeply delaminated.

Medina sandstone used in all concrete.

1 foot deep scale on south abutment

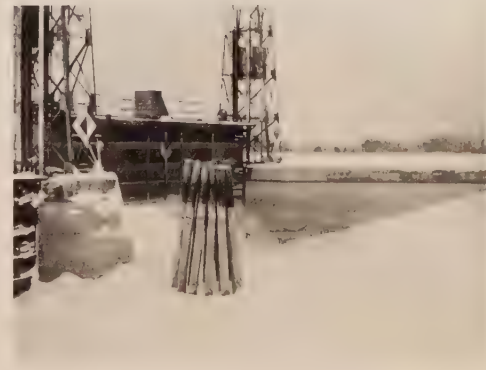
East Half North Abutment and Center Pier
Middleport Guard Gate

All walls of the guard gate were found to be 100% delaminated. Coring revealed that the majority of these delaminations extended deeply into the walls. Areas of scaling up to 1 foot deep existed on the south abutment and the top 6 feet of the center of the north abutment has been recently repaired.

This guard gate was constructed with concrete containing crushed Medina sandstone coarse aggregate. This concrete has not held up as well as the concretes containing gravel coarse aggregates used in most other structures. Deterioration was generally found to be much more extensive and deeper in those structures containing Medina sandstone as the coarse aggregate.

We believe that the concrete in this structure is fractured halfway or more through most walls. Although still mostly intact, complete replacement or very extensive repair is recommended for the near future.

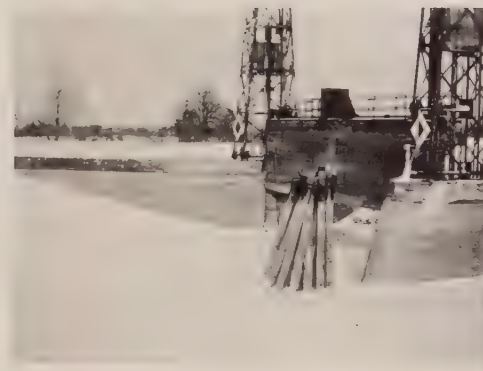
Core #2, obtained from the center pier, revealed fractured concrete to a depth of 9 inches. Although equipment problems prevented deeper coring of the pier, deterioration in excess of 9 inches exists in most areas of the pier.

West Half North Abutment and Center Pier
Middleport Guard Gate

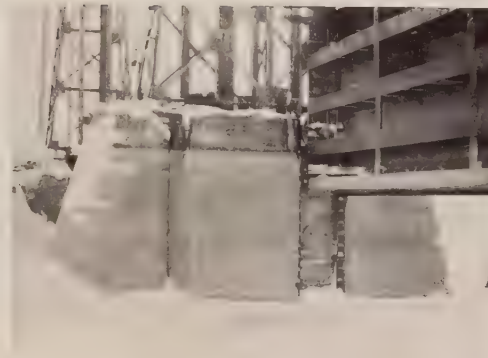
North side center pier
Middleport Guard Gate

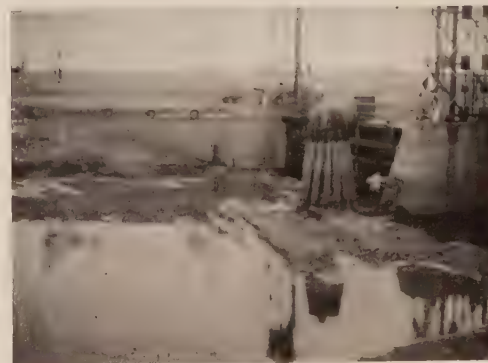
East Half South Abutment and Center Pier
Middleport Guard Gate

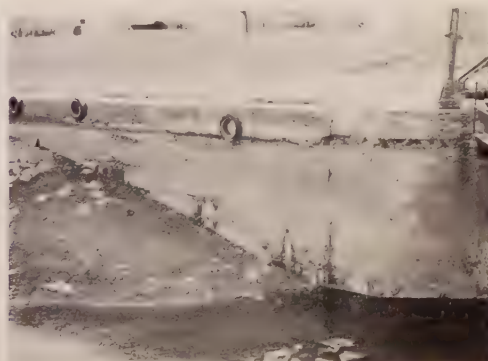
Core #1, taken from near the bottom of the south abutment, showed that deterioration continued beyond 2 feet into the wall.

East Section of South Abutment
Note Core Hole

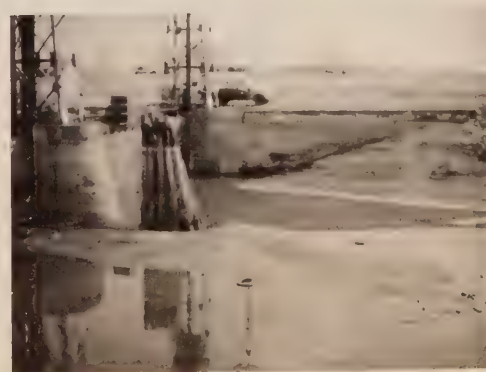
West Half South Abutment and Center Pier
Middleport Guard Gate

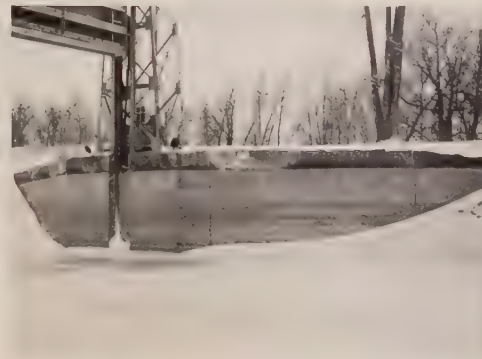
North Abutment
Gasport Guard Gate

On the north abutment, no delaminated concrete was detected, except for the usual deterioration located in the top 2-3 feet. The wall face appeared in good condition with only a few small scaled areas.

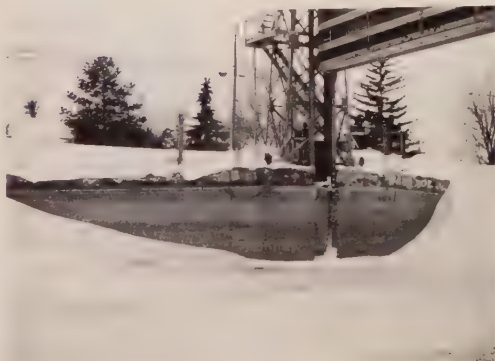
The south abutment contained large areas of delaminated concrete, many cracks and a few scaled areas. Cores #1 and 2, taken near the bottom of the abutment, showed that deterioration extends 13 inches and 8 inches, respectively, into the concrete. Core #1 had a compressive strength of 6125 p.s.i. even though the lower section tested contained 1 or 2 small fractures.

South Abutment
Gasport Guard Gate

Although large areas of this structure appear to be in relatively good condition, future concrete repairs are recommended for the more seriously deteriorated areas. These repairs should include replacement of the concrete in the top 2-3 feet of the walls and pier. Also, all areas which contained delaminated and/or deteriorated concrete should be repaired by removing the existing concrete to an approximate depth of 8-12 inches and bonding on a new concrete surface.

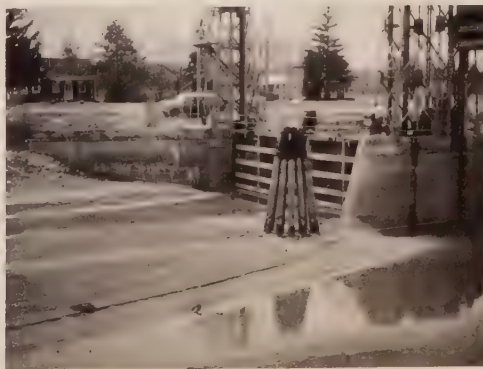
East Half South Abutment
Gasport Guard Gate

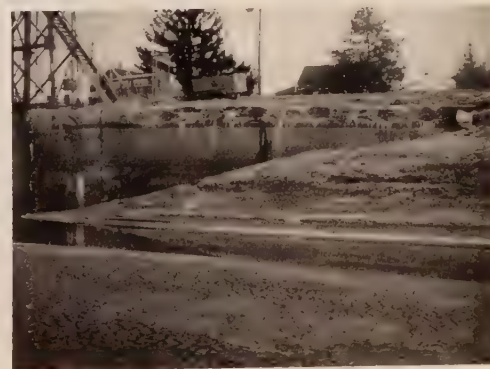
West Half South Abutment
Gasport Guard Gate

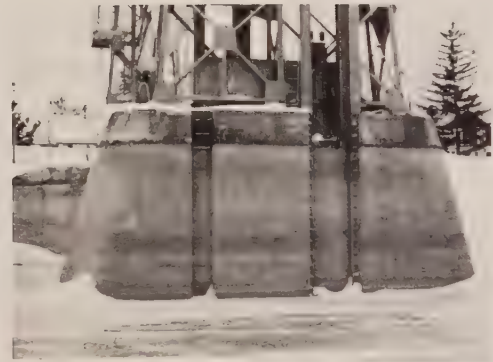
The north side of the center pier also was in good condition with no delaminations detected. However, the south side and the pier noses contained large areas of delaminated concrete. Some surface scaling has also occurred in these areas. Overall, the concrete in the pier still appeared in relatively good condition.

North Side Center Pier
Gasport Guard Gate

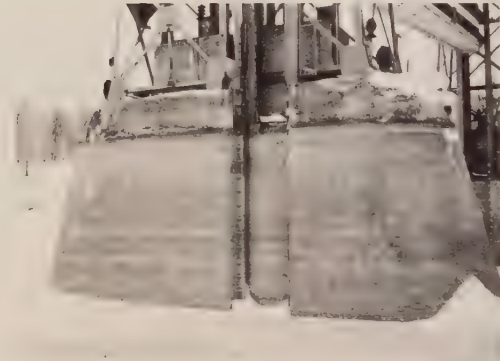
South Side Center Pier
Gasport Guard Gate

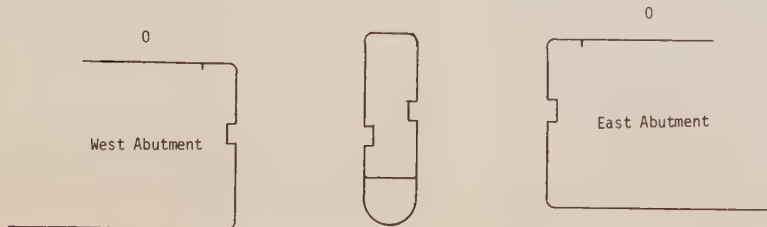
Water too deep to
sound center pier.

All north side concrete
looks in good condition

Most south side concrete above water
looks scaled, cracked and delaminated.

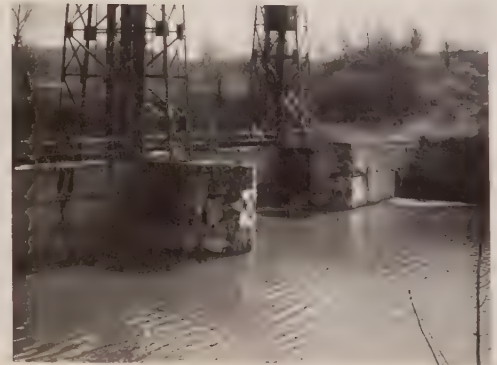
West Side Center Pier and East Abutment
Pendleton Guard Gate

On the south side, above the water line, practically all concrete appeared in fair condition. Although presently intact, the 9 foot high concrete nose on the center pier was cracked, delaminated, and the surface scaled. Both abutments were in better condition, but cracks, scaling and delaminations were widespread. Concrete below

The concrete in this structure is still in relatively good condition and no immediate repairs are recommended. Future repairs should include removal and replacement of 8 inches or more of concrete on the wall faces and tops, and replacement of the 9 foot high pier nose section. The majority of these repairs will be required only on the south side of the gate.

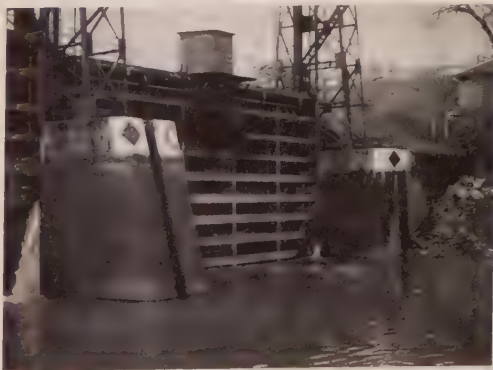
East Side Center Pier and West Abutment
Pendleton Guard Gate

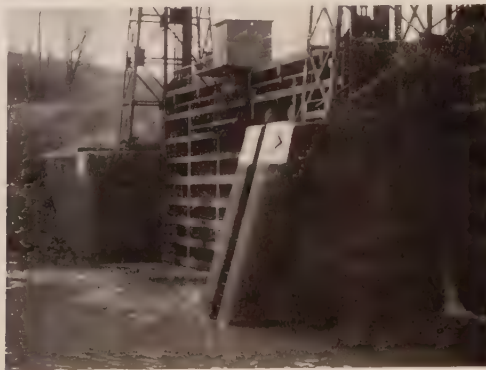
West Side Center Pier and East Abutment
Pendleton Guard Gate

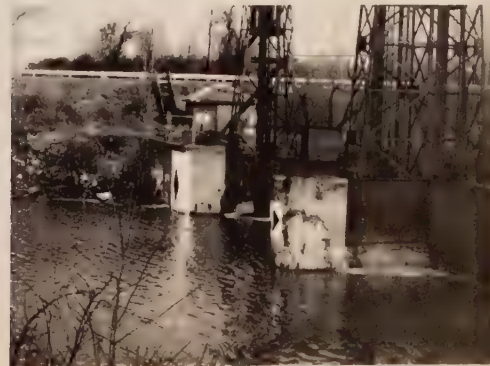
East Side Center Pier and West Abutment
Pendleton Guard Gate

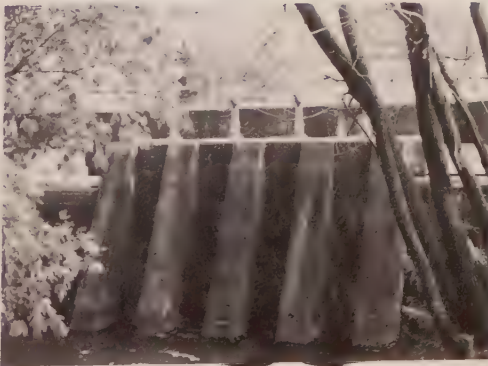
The membrane wall and buttresses of the waste gate appeared in very good condition with only a few small cracks and no delaminations or scaling. Deep water prevented sounding the lower wall surfaces.

North Side
Fairport Waste Gate

This structure is still in good condition and only isolated repairs are presently recommended.

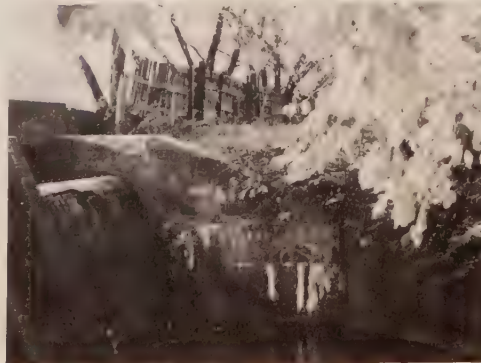
Both weirs also appeared in good condition. A few cracks were denoted by efflorescence and small isolated spots of scaling existed. The only problem seen on the structure was that the top 6 inches of the west weir crest was delaminated. The east weir crest was in much better condition with only a few small scaled areas. A number of cracks existed on the abutments and some scaling and delamination has occurred on top of the west abutment.

West Abutment
Fairport Weir

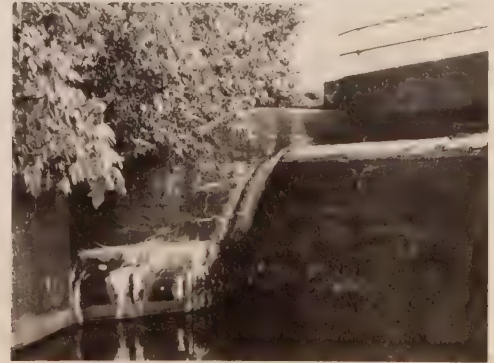
East Abutment and East Half of Weir
Fairport Weir

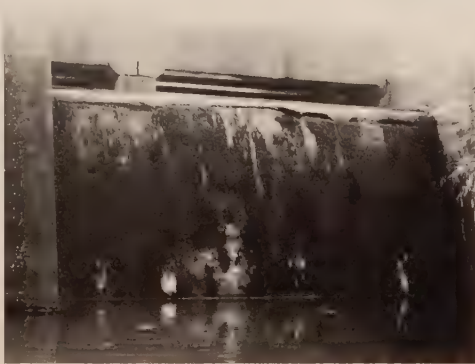
West Half, Note crack along crest
Fairport Weir

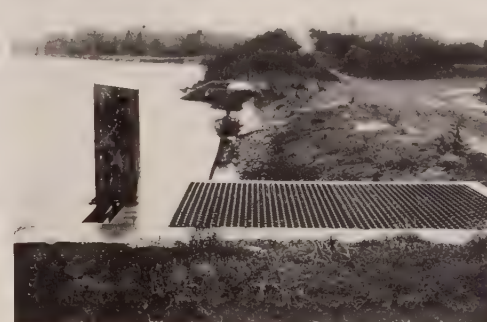
Looking West, Note new waste gate in foreground.
Greece Weir

This new waste gate was in excellent condition and no work is recommended.

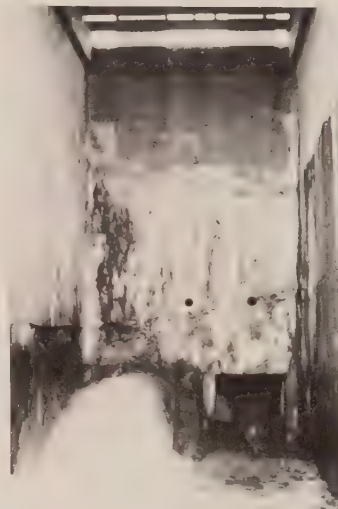
The bottom 10 feet of the membrane wall was heavily effloresced on the north or front side and some seepage of canal water through this section was evident. A cold joint ran horizontally across the wall 5 to 6 feet from the bottom. Approximately 70% of the wall was effloresced and 50% sounded delaminated. The top section of the wall appeared and sounded in good condition.

Cores #1 and 2, taken from the front of the gate, showed deterioration to a depth greater than 1 foot. Core #3, taken from the back or canal side of the gate, showed deterioration to a 6 inch depth. Although the lower sections of Cores #2 and 3 contained 1 or 2 small fractures, they had compressive strengths of 3225 and 5420 p.s.i., respectively.

North Side, Core Hole #1 (right) and #2 (left), Note joints across wall.
Spencerport Waste Gate

| <u>Core Number</u> | <u>Location</u> | <u>Scaled Depth</u> | <u>Deteriorated Depth</u> | <u>Intentional Breaks</u> | <u>Recovered Depth</u> | <u>Total Depth</u> | <u>Comments</u> |
|---|--|---|---|---|---|---|---|
| 1 | Waste Gate, North Side, 2' From West Abutment, 6' Above Floor | 0 | 12½" | 0 | 12½" | 12½" | Cored through cold joint. Deeper deterioration exists. |

The depth of concrete deterioration in the waste gate membrane wall, although reinforced, indicates that this part of the water control structure should be rebuilt now. Both abutments and the bridge pier also need to be repaired or replaced. The weir is in good condition and no additional work is anticipated for this part of the structure.

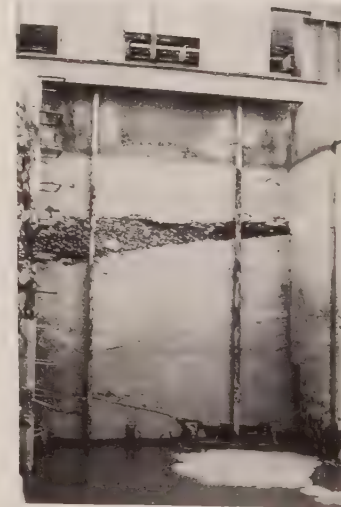
Canal or South Side, Note cold joints across wall. Spencerport Waste Gate

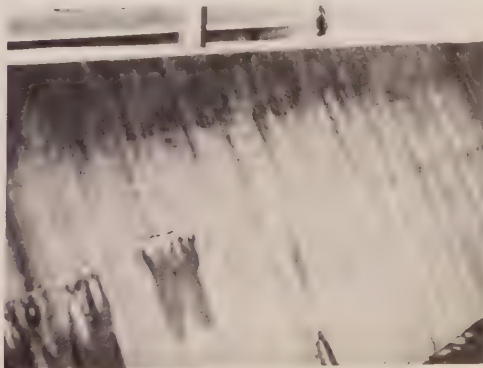
In the middle 1960's State Maintenance Forces rebuilt the upper half of the weir and reconstructed the tow path bridge. Core #5, taken from a non-reconstructed area on the back side of the weir, contained deterioration 6 inches deep. Core #6, obtained from a reconstructed area on the front of the weir, showed no deterioration. Core #6 was taken through a vertical crack which extends the full length of the core. No water was leaking through this crack, but canal water was rising out of a small crack at the toe of the weir. Less than 5% of the weir exhibited any form of deterioration. Although it contained 1 or 2 small fractures, the middle section of Core #5 had a compressive strength of 6265 p.s.i.

North Side
Spencerport Weir

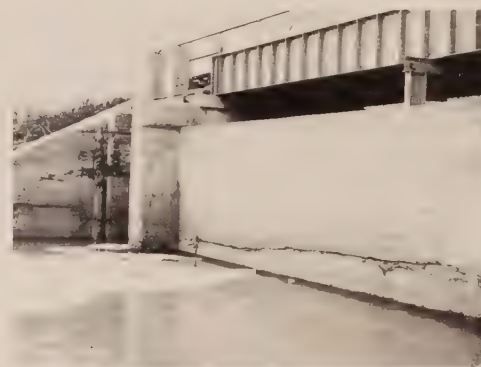
South Side, Looking West, Note repairs to
top half of weir. Spencerport Weir

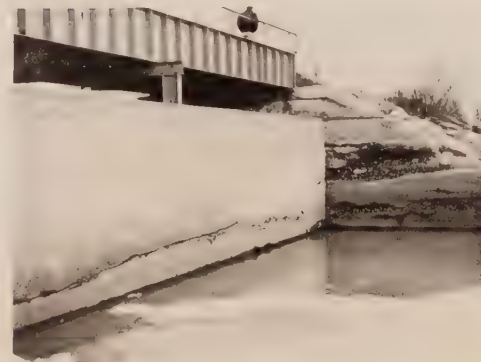
South Side, Looking East, Note repairs to
top of weir and deteriorated east abutment.
Spencerport Weir

The north half of the east abutment had cracks and efflorescence on approximately 90% of its surface and scaling or delaminations on 60% of its surface. Core #7, taken from this wall on April 26, 1977, was located in a hollow sounding area with 1 foot deep scaled areas above and below the core hole. The core showed that deterioration extends over 2½ feet into the abutment. The south half of the east

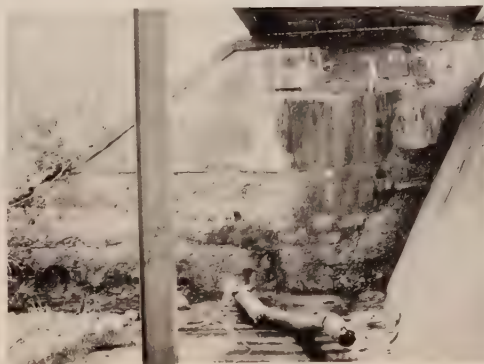
East Abutment
Spencerport Weir

abutment (normally under water on canal side) had two long, horizontal, deep scale areas. The remainder of the surface contained few delaminations, but Core #4 showed deterioration to a depth of 5 inches.

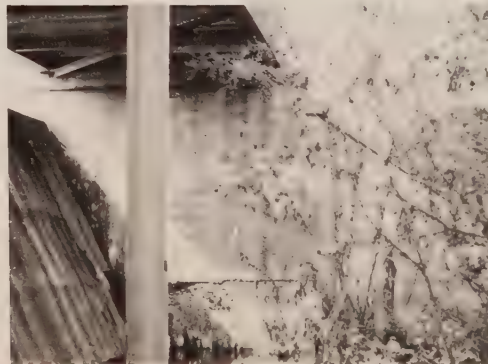
The surface of the tow path bridge pier was 60% covered with cracks and efflorescence, 30% scaled and 25% delaminated.

Looking West, East Side of Pier
and Wingwall of West Abutment.
Spencerport Waste Gate and Weir

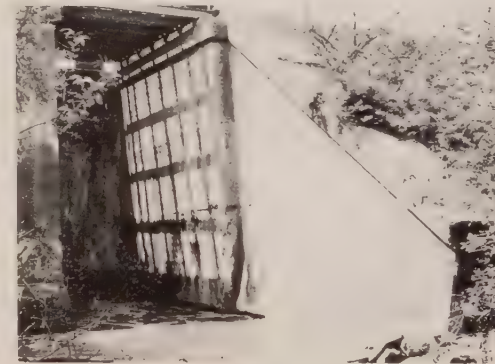
West Abutment
Spencerport Waste Gate

The west abutment exhibited large cracks on approximately 20% of its area. The majority of these cracks probably extend through the wall. Small cracks and efflorescence covered approximately 60% of the abutment surface and delaminations were detected on 40% of its surface. The south end of the west abutment (normally under water on canal side) had small areas of scaling and cracks along the top, but few delaminations were detected on the front surface.

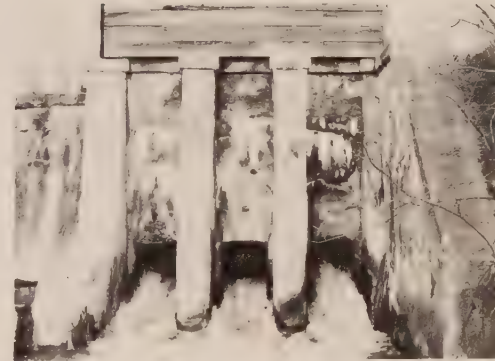
The waste gate has three sluice gate openings and two buttresses to reinforce the membrane wall. The shotcrete coating made it difficult to sound the structure and detect delaminations. Sounding of areas not covered with shotcrete revealed some delaminations. Cores #1 and #3 were taken in areas of the membrane wall which represent typical conditions. These cores showed deterioration to 10 and 7 inches, respectively. The lower section of Core #1 had a compressive strength of 4030 p.s.i. even though it contained 1 or 2 small fractures.

South Side, Note Core Holes #1 and 3
Adams Basin Waste Gate

Cores taken from this structure indicate deterioration exists from 4 to 10 inches in depth. We believe that similar deterioration exists in the abutment walls and that the weir crest needs replacement. Repair procedures would include chipping deteriorated concrete until sound concrete is reached and then encasing the structure in new concrete to prevent further deterioration.

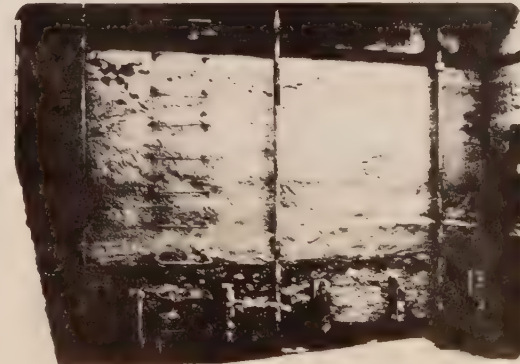
Canal Side
Adams Basin Waste Gate

Core #2, taken in a typical area of a buttress, showed deterioration existed to a depth of 4 inches. However, close examination of the sloping buttress faces indicated that deterioration existed here to an approximate depth of 12 inches.

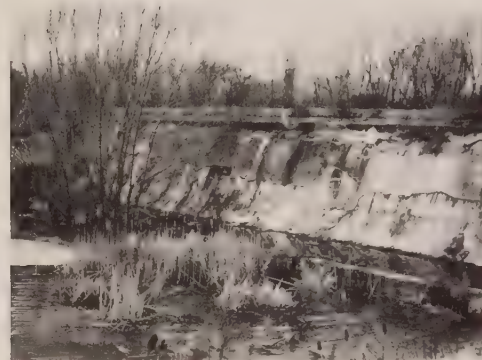
Approximately half of the shotcrete placed on the front of the weir has fallen off and most of the remaining shotcrete was only loosely bonded. The exposed concrete surface was lightly scaled with about 25% of the concrete being delaminated. Water seeping from beneath the shotcrete was most likely coming from the crest of the weir where the top 2 feet appeared to be deteriorated. Scattered vegetation was growing along the crest of the weir. Core #4, taken from the front of the weir, indicated deterioration to 8 inches in this delaminated area. The lower section of Core #4 had a compressive strength of 3640 p.s.i.

South Side, Note missing shotcrete and vegetation along crest.

Since the shotcrete placed on the existing concrete was only loosely bonded, and in some areas had fallen off, we believe that this cosmetic method of repair has little merit. In all cases, it has hindered the evaluation of the structures.

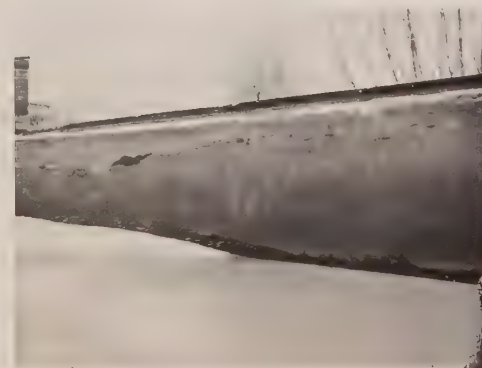
Canal Side, Note repairs along crest
Adams Basin Weir

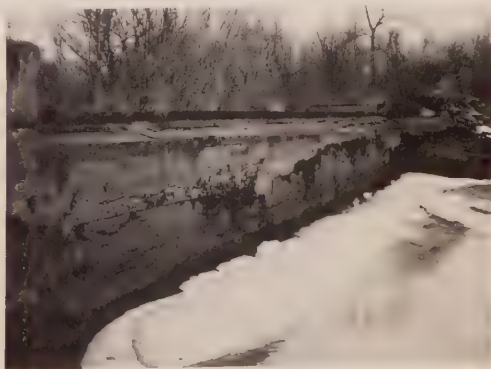
North or Canal Side
Note repairs along top of weir.
Adams Basin Weir

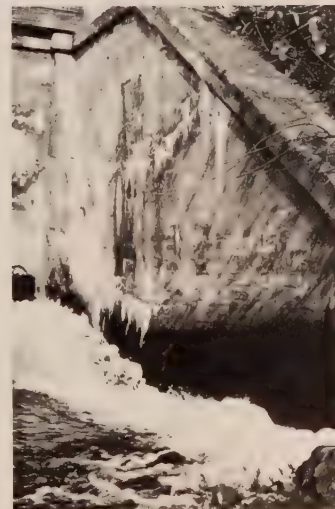
East Abutment
Adams Basin Waste Gate

The east abutment, not covered with shotcrete, was approximately 75% cracked and exhibited efflorescence. Delaminated areas existed on over half of the surface. At one time, the west abutment was completely covered with shotcrete, but 25% has now fallen off. The exposed concrete sounded delaminated, and 50% of this exposed surface was cracked and effloresced.

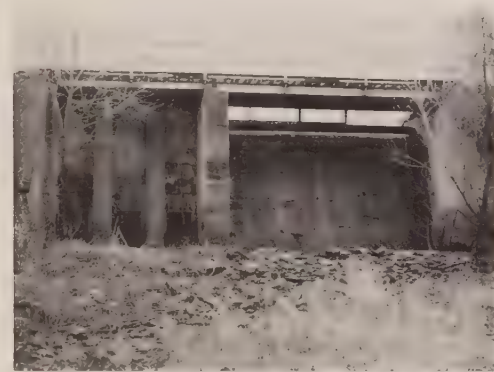
The waste gate and buttress walls appeared to be in very good condition. Less than 5% of its surface was scaled or delaminated. Core #1, taken from a typical area in the membrane wall, revealed no deterioration. This core had a compressive strength of 4185 p.s.i.

The weir exhibited scaling 1 to 2 inches in depth over approximately 10% of its area. Sounding revealed delaminations covering less than 5% of its surface. Core #2, taken in a typical weir area, revealed no deterioration of the concrete, but the concrete was cracked about 5 inches below the surface.

North Side, Note core holes #1 and 2
Brockport Weir and Waste Gate

The waste gate, weir, and abutments were in very good condition. No repair work is presently anticipated.

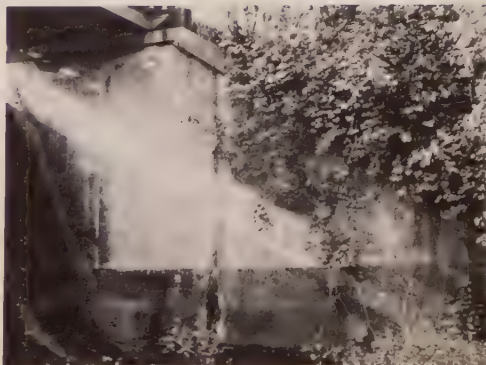
West Abutment
Brockport Weir

Both abutments were in good condition with scaled or delaminated areas covering less than 5% of the surface area.

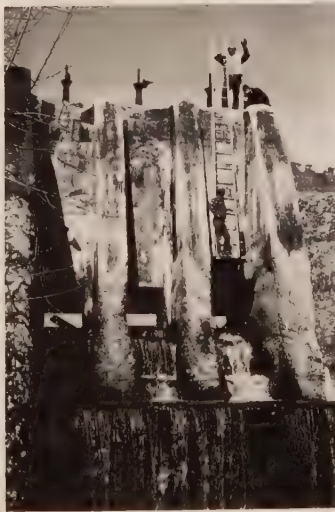
The waste gate membrane wall exhibited scaling, efflorescence, and delaminations covering 90% of its south side. Cores #4 and 5, taken from the south side of the membrane wall, indicated deterioration to 6 and 9 inches, respectively. The north side of the membrane wall exhibited deep cracking. Core #7, taken from the north side of this wall, indicated deterioration deeper than 11 1/2 inches. The buttresses were scaled along their outer edges, but for the most part appeared sound. Core #6, taken from a center buttress in a typical area, indicated deterioration to 3 inches. Although both cores had 1 or 2 small fractures, Cores #4 and #6 had compressive strengths of 4040 and 3600 p.s.i., respectively.

South Side, Note energy dissipation pool in foreground. Holley Waste Gate

Repairs to all structure components should include removal of unsound concrete and bonding new concrete to sound concrete surfaces.

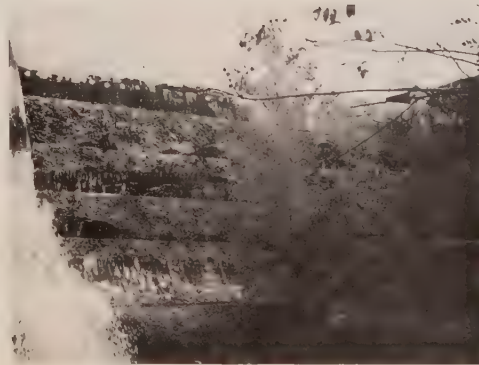
South Side
Holley Weir

Canal Maintenance Forces have repaired the top of the east abutment and the crest of the weir. Most of the south side of the weir exhibited scaling and delaminations. Core #1, from the south side of the weir, indicated deterioration existed to a 18 inch depth. The north side exhibited deep cracking. Core #3, from the north side of the weir, indicated deterioration deeper than 21 inches.

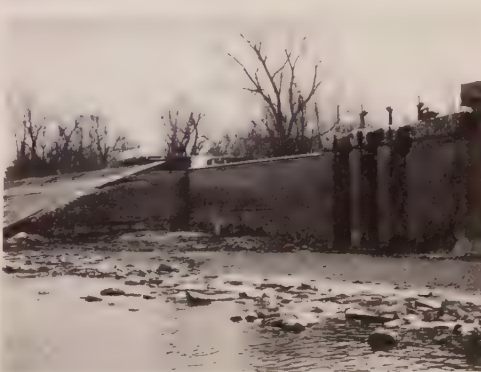
Canal Side, Note repairs to weir
crest and top of east abutment.
Holley Waste Gate and Weir

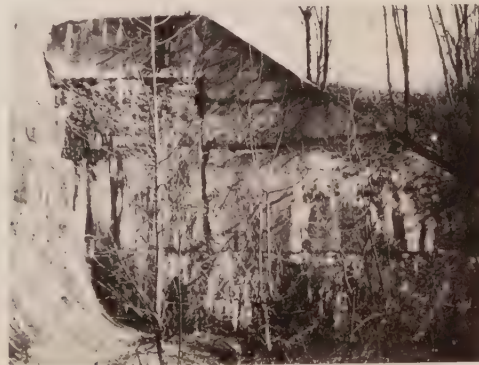
East Abutment
Holley Weir

The south half of the east abutment wall was cracked or delaminated over approximately half of its surface. Core #2, taken from this abutment, indicated deterioration to 18 inches. The north half of the east abutment wall exhibited deep scaling along its lower section. The west abutment was mostly sound.

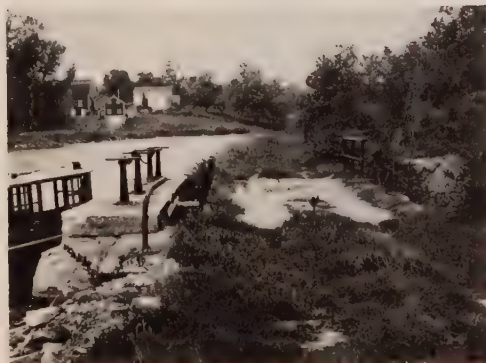
Looking West, Note partially missing railing. Brockville Waste Gate and Weir

Approximately two-thirds of the tow path bridge railing was missing. This railing should be replaced.

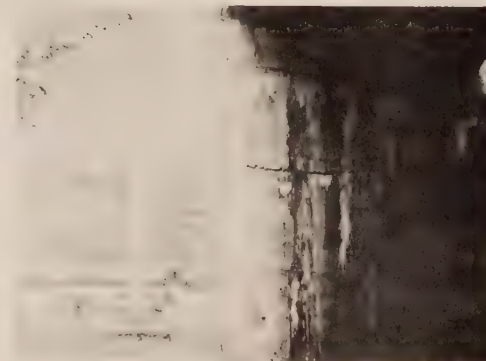
East Abutment
Brockville Weir

The slab supporting the gate valve standards contained deterioration in the form of scaling or cracking over approximately 15% of its surface. Both abutments exhibited cracking or efflorescence covering about 20% of their surfaces, but basically they were sound.

Deterioration in this structure is confined to scaling and cracking along the edges of the slabs and pier. Repairs to these areas are recommended.

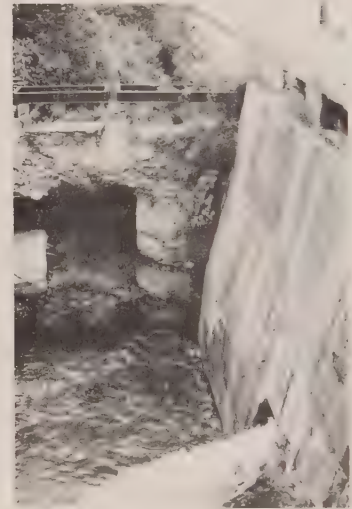
Looking West
Albion Weir

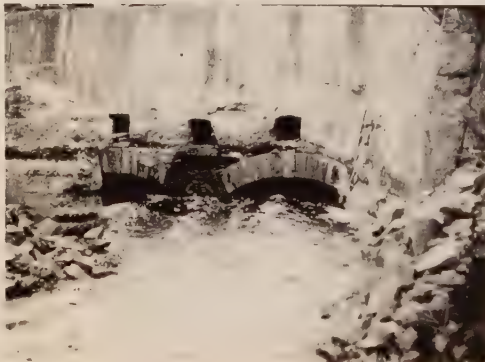
Albion Waste Gate and Culvert 77
Entrance After Cleaning Out, 1976
Note Core Hole #1

Three of the 4 sluice gate openings in the waste gate are located directly over Culvert 77. The 4th sluice gate discharged into an old canal drydock area which was abandoned and walled off before the Barge Canal was built. This sluice gate is plugged with concrete and inoperative. Soundings along the upper south side of the waste gate revealed little delamination. Scaling, delamination and other deterioration existed in the vicinity of the sluice gate openings. Core #1, taken from the south side of the waste gate, revealed a sound facing 16 inches in depth, and an older concrete facing beneath it. Core #2, taken directly opposite of Core #1, on the canal side of the waste gate, indicated deterioration to 6 inches in depth.

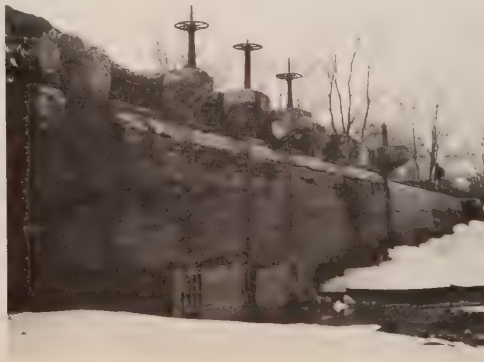
Canal Side
Albion Waste Gate and Weir

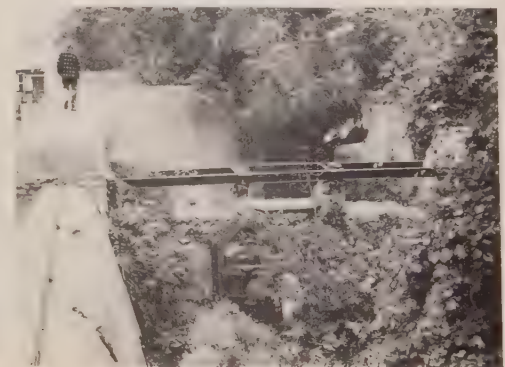
Looking East, Note old dry dock valves
and pipeline pedestals partially hidden
by vegetation. Albion Weir

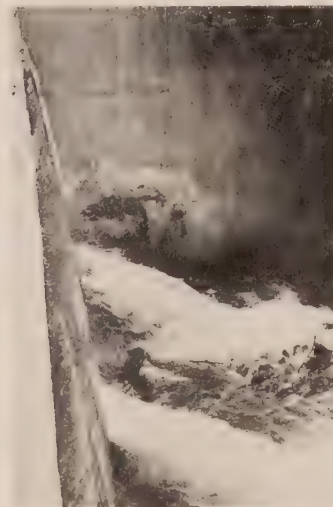
The concrete which encases the weir was mostly sound. The west half of the weir (notch area) showed some distress along its upper portion where vegetation was observed growing. The east abutment appeared to be in very good condition. Little scaling or delamination was observed along this abutment.

East Abutment
Albion Weir

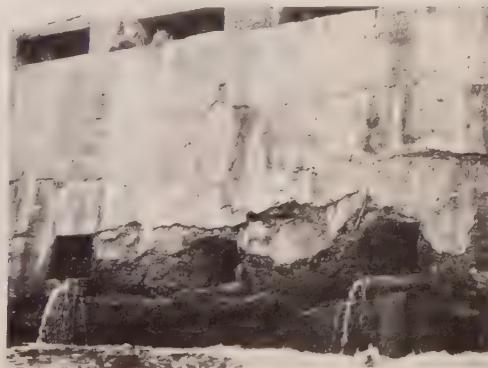
Albion Waste Gate and Culvert 77
Entrance, 1975

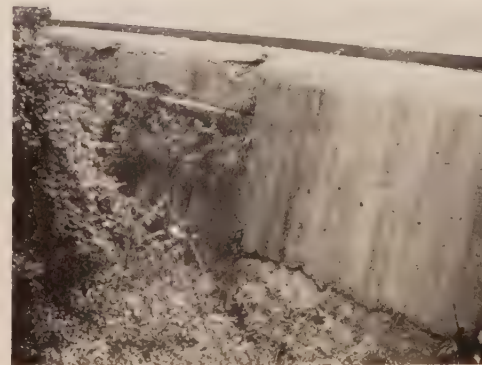
Recent Repairs on East Half of Weir
Albion Weir

The concrete encased masonry waste gate and weir are sound. An old mill foundation and the dry dock walls in front of the waste gate and weir make the structure appear to be in worse condition than it actually is. Future repairs should include repair or removal of the concrete slabs and valve standard pedestals. The deteriorated concrete around the 3 sluice gate openings should be removed and replaced with a durable concrete bonded to the existing structure. These repairs should be in conjunction with repairs to Culvert 77 which is directly underneath. Those sections of the weir which show deterioration should be removed and replaced with concrete.

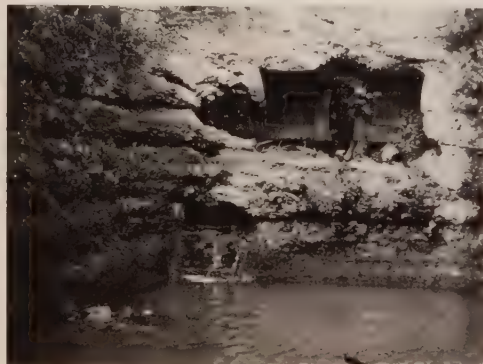
The west abutment is stone masonry. A small stream of water was observed coming through this wall area which was hidden by dense vegetation.

Old Dry Dock Valves, Note quantity of leak water coming out dark hole which comes through rubble wall at west end of Albion Weir

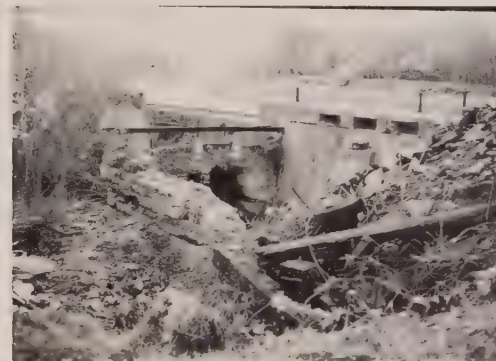
Albion Waste Gate Area
After Being Cleaned Out

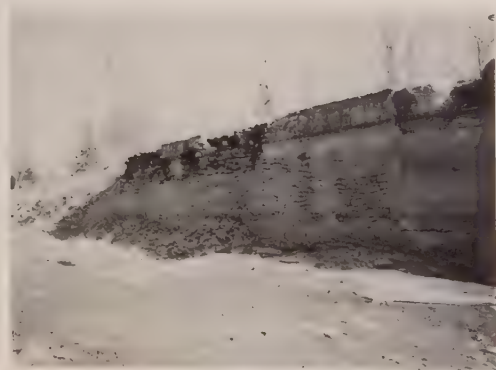
Stone Wall East of
Albion Waste Gate

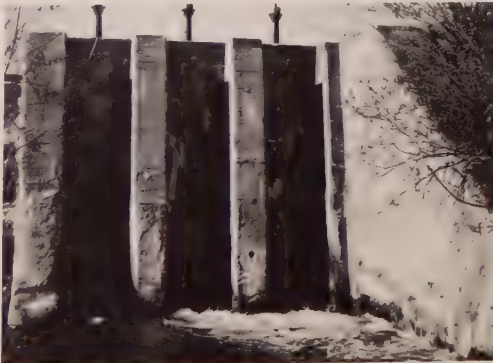
Cores #1 and 3, taken from the membrane wall of the waste gate, indicated deterioration to 4 inches in depth. Cores #1 and 3 had compressive strengths of 5790 and 9175 p.s.i. respectively. A close examination of the buttresses indicated severe deterioration along their outer extremities. Core #2, which was cored into the end of a buttress and toward the membrane wall, revealed that the outer 2 feet of the buttresses were rubble.

South Side, Note core holes #1, 2 and 3, right to left. Eagle Harbor Waste Gate

Future repair work should include removal of the shotcrete and deteriorated concrete to sound material. The structure should then be encased in new concrete to prevent further deterioration.

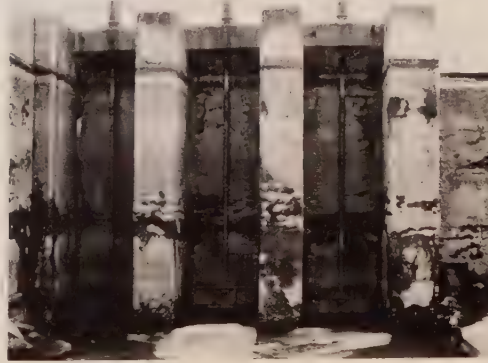
Canal Side
Eagle Harbor Waste Gate

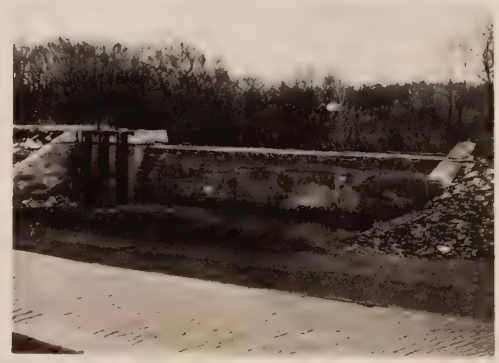
Canal Side, Note repairs along crest of weir. Eagle Harbor Weir and Waste Gate

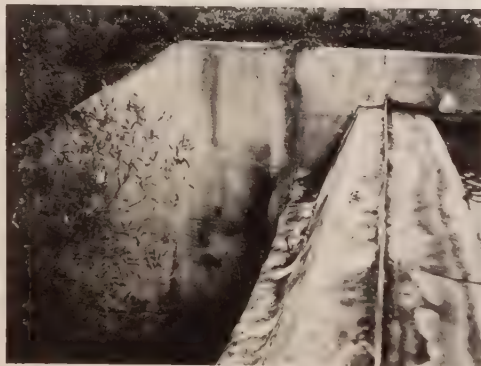
Both abutments were covered with shotcrete, but soundings in areas where the shotcrete has fallen off indicated less than 10% of the surface delaminated.

West Abutment
Eagle Harbor Weir

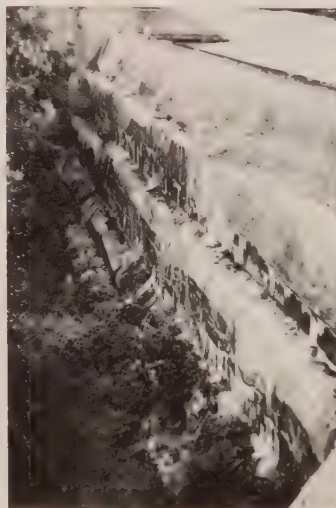
Looking West
Eagle Harbor Weir

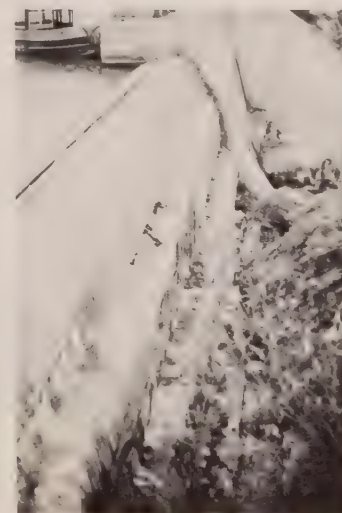
Looking East
Eagle Harbor Weir

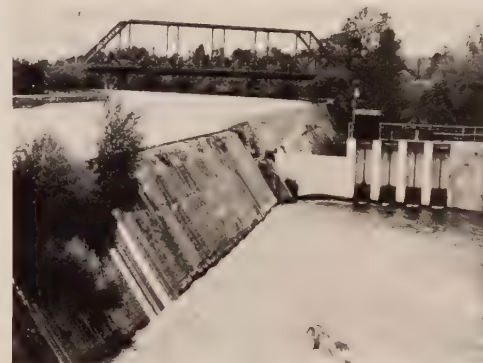
Looking East, Niagara Mohawk Waste Gates at right, Medina Trough (Culvert 99, Medina Aqueduct) in background. Medina Weir

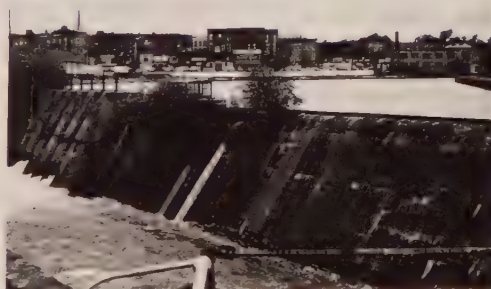
Looking West, Medina Harbor in background. Note vegetation on weir. Medina Waste Gate and Weir

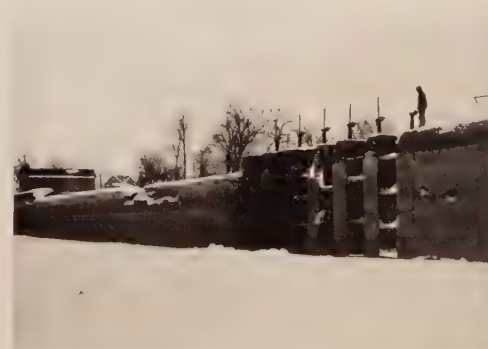
Canal or North Side Medina Weir and Waste Gate

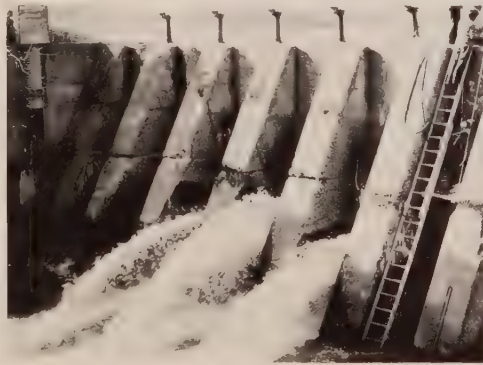
The waste gate is 18 1/2 feet high and 45 feet long with six sluice gates. Gate #1 was closed and inoperative, and gates #3, 4, and 5 leaked a considerable amount of water when closed. A horizontal construction joint approximately 9 feet from the bottom had deteriorated to the point where water was leaking through it. Three sections of the membrane wall contained vertical cracks extending from the top down to the construction joint and completely through the wall. All buttresses, except the center one, have cracks from their outside edges extending downward in a diagonal direction to the construction joint of the membrane wall. Vegetation was growing from these joints and cracks.

Leakage Through Closed Gates, Note
horizontal joint and vertical cracks.
Medina Waste Gates

Further deterioration and cracks in the membrane wall and buttresses greatly reduce the factor of safety used in the design of the waste gate. We therefore recommend that all deteriorated concrete be removed to sound material. The entire structure should then be encased in new concrete to prevent seepage of water through the cracks and stop freeze-thaw deterioration of the existing concrete.

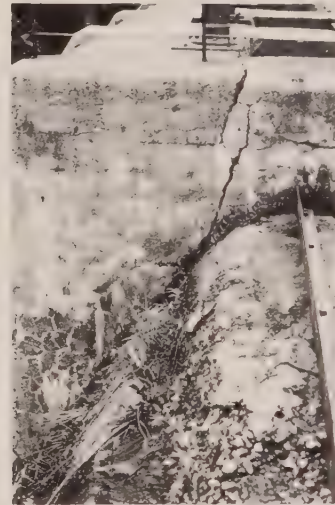
Looking West, Cracks in top of waste gate.
Medina Weir and Waste Gate

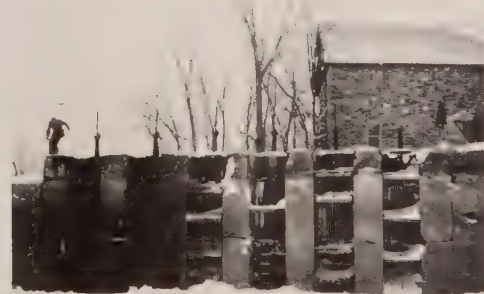
Canal Side
Medina Waste Gates
Note kids at left using top of weir as short cut.

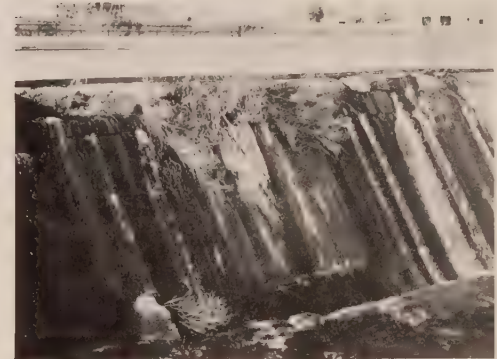
Sounding along the bottom of the south side of the weir indicated some delaminated areas and the weir exhibited only minor scaling. The top portion of the weir, mainly the west half, was seriously deteriorated with numerous cracks and chunks of concrete missing. Water was running freely through cracks and the construction joint, and brush was growing along the crest. The north side of the weir exhibited deep deterioration along its top, but the lower section was in good condition.

West End of Weir, Area of Filled Notches
Medina Weir

The top of the weir, especially the west half, should be removed and replaced. Any other deteriorated concrete found should be removed until sound concrete is reached. The weir should then be encased in new concrete to prevent further deterioration.
